Schneider Home Inspections LLC Property Inspection Report

1234 S. Oak St., Leavenworth KS, 66048 Inspection prepared for: Trent Schneider Inspection Date: 11/30/2009 Time: 9:00 AM Age: New Weather: Clear

Inspector: Trent Schneider ASHI #243034 3950 S 21st St., Leavenworth, KS, 66048 Phone: 913-547-1229 Email: trentschneider@hotmail.com www.schneiderinspections.com

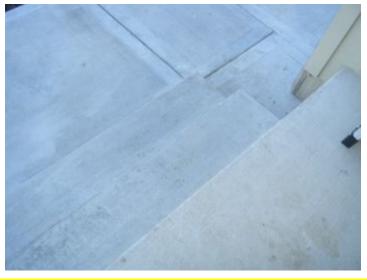
1. Entry Stoop

• Action Needed - The current staircase condition presents an unsafe condition or trip hazard. There is either no handrail installed or it needs repair or replacement.

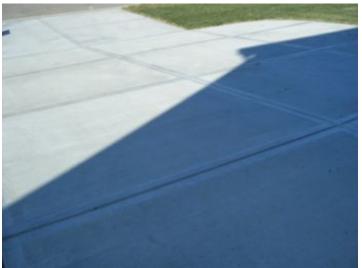
2. Driveway

Concrete Satisfactory - The driveway surface material is in satisfactory condition.

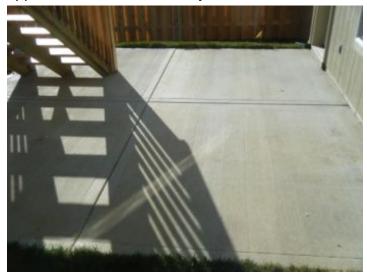
4. Patio

• Satisfactory - The slab appears to be in satisfactory condition.

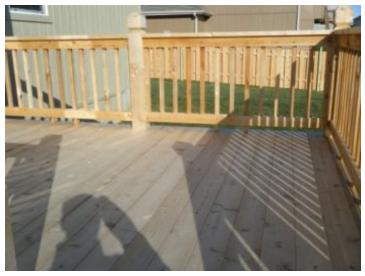
5. Deck

- Satisfactory The wood materials are in satisfactory condition.The deck appears to be bolt to the structure.
- The spacing between the balusers is 4" inches. This was instituted as a safety issue to prevent small children from getting caught between the balusters.

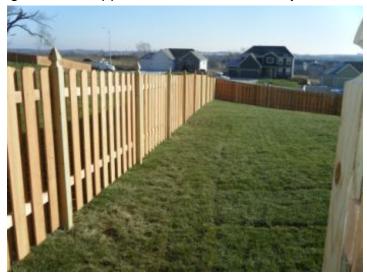
8. Fence Condition

• Satisfactory - the fencing materials appear to be in a satisfactory condition.

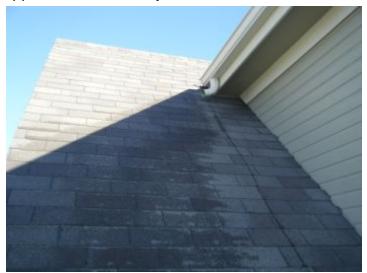
2. Roof Condition

• Satisfactory - The roof appears in satisfactory condition.

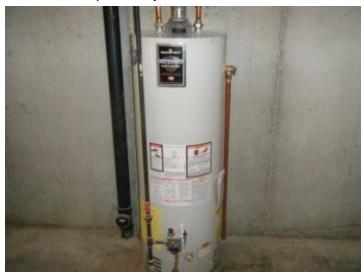
- 5. Exposed Condition
- Good Rust free and clean. Should provide years of service.

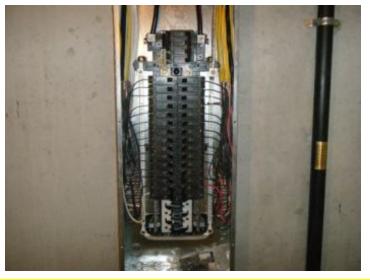
- 3. Panel Accessible
- Satisfactory The electrical panel is in a location that makes it accessible.
- 4. Panel Condition
- Satisfactory The main panel is in satisfactory condition.

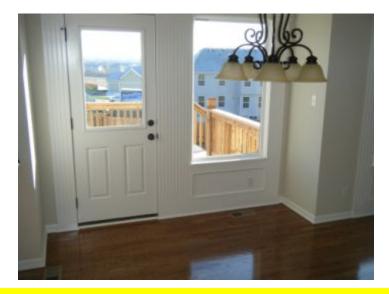
• Attention Needed - The lock on the door needs adjustment.
